# Manhole Inspection Summary

Manhole # S41K\_\_031MH

Insp Date: **9/8/08 11:40 AM**

**Location** Address: **rear 900 fleet st**

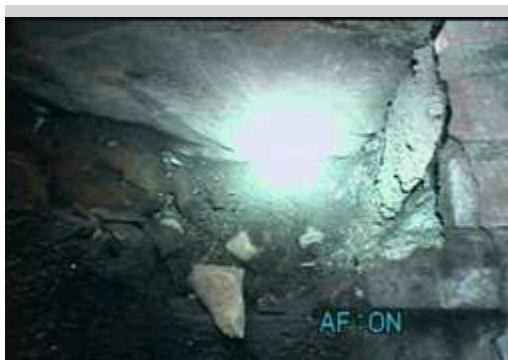
Defect 4

**Corbel** Material: **Brick** ☐ Parged Type: **Concentric/Eccentric**

Condition: ☐ Sound ☒ **Cracked** ☐ Root Intrusion ☒ **Loose Brick** ☒ **Deteriorated**

Infiltration: ☐ None ☐ Joint ☒ **Cracks** ☒ **Mortar** ☐ Roots ☐ Wall

corbel cracked, loose bricks, deteriorated with infiltration from mortar & cracks

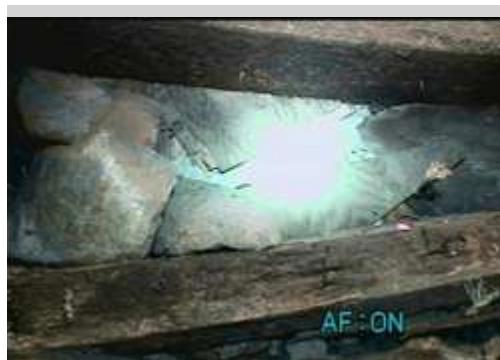
Defect 3

**Chimney / Frame Adjustment** ☒ Exists Material: **Brick and Stone** ☐ Parged Height: **10** (in.)

Condition: ☐ Sound ☒ **Cracked** ☐ Root Intrusion ☒ **Loose Brick** ☒ **Deteriorated**

cracked, loose bricks, deteriorated

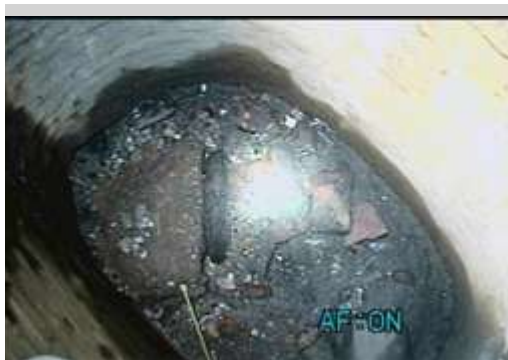
Defect 1

Condition: ☐ Sound ☐ Cracked ☐ Root Intrusion ☐ Deteriorated ☐ Leaks ☒ **Debris**

channel debris

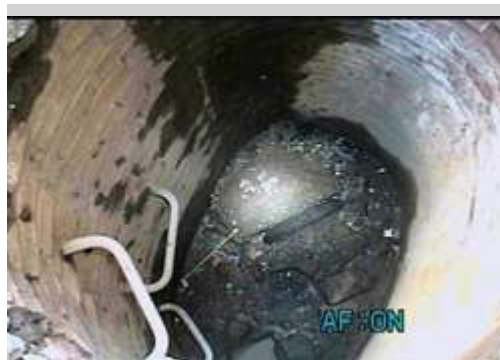
Defect 2

Infiltration: ☐ None ☐ Joint ☐ Cracks ☐ Mortar ☐ Roots ☒ **Wall**

barrel wall infiltration

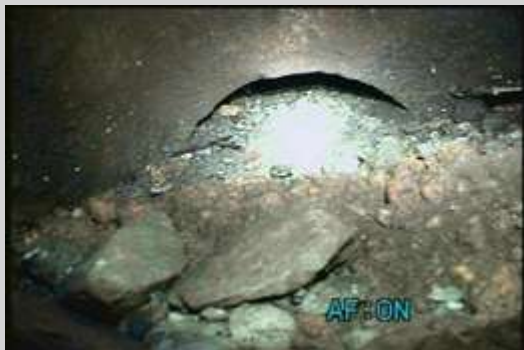
12 O'Clock Outflow

to much debris to see in 12

Deposits: ☐ None ☐ Mud ☐ Sludge ☒ **Debris** ☐ Grease

Silt Depth: 7 (in.) Deposits Extent: **Heavy**
